# Oakleaf Town Center Community Development District

DUVAL COUNTY, FLORIDA

ENGINEER'S 2025 ANNUAL REPORT (REVISED FEBRUARY 11, 2026)

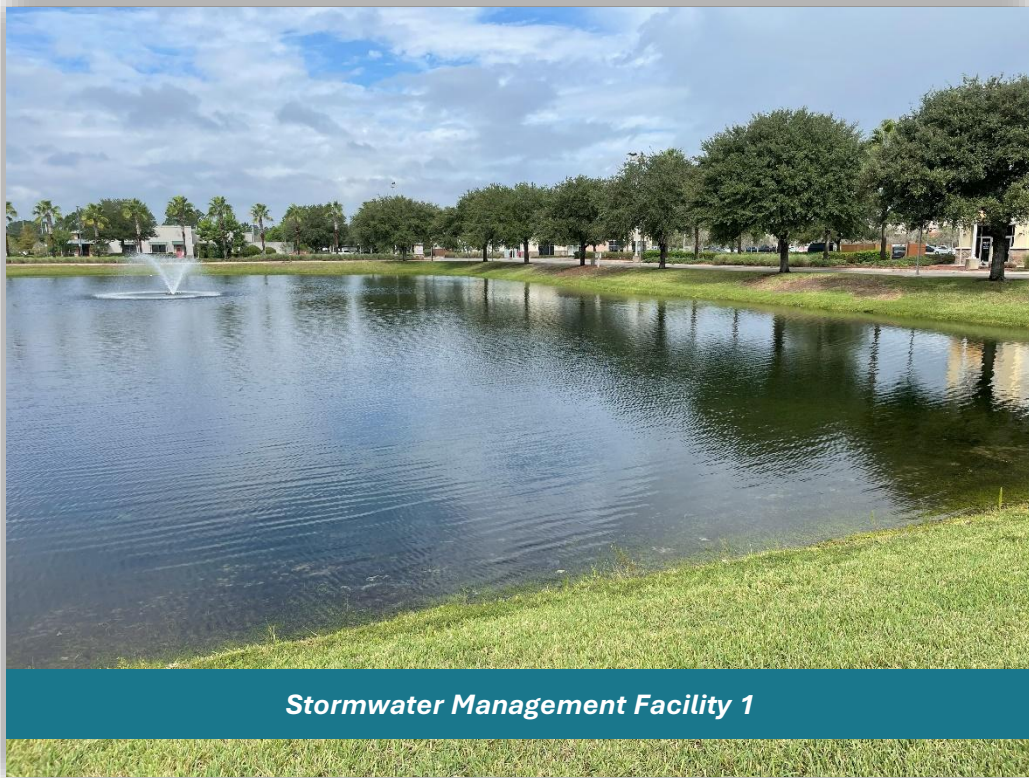
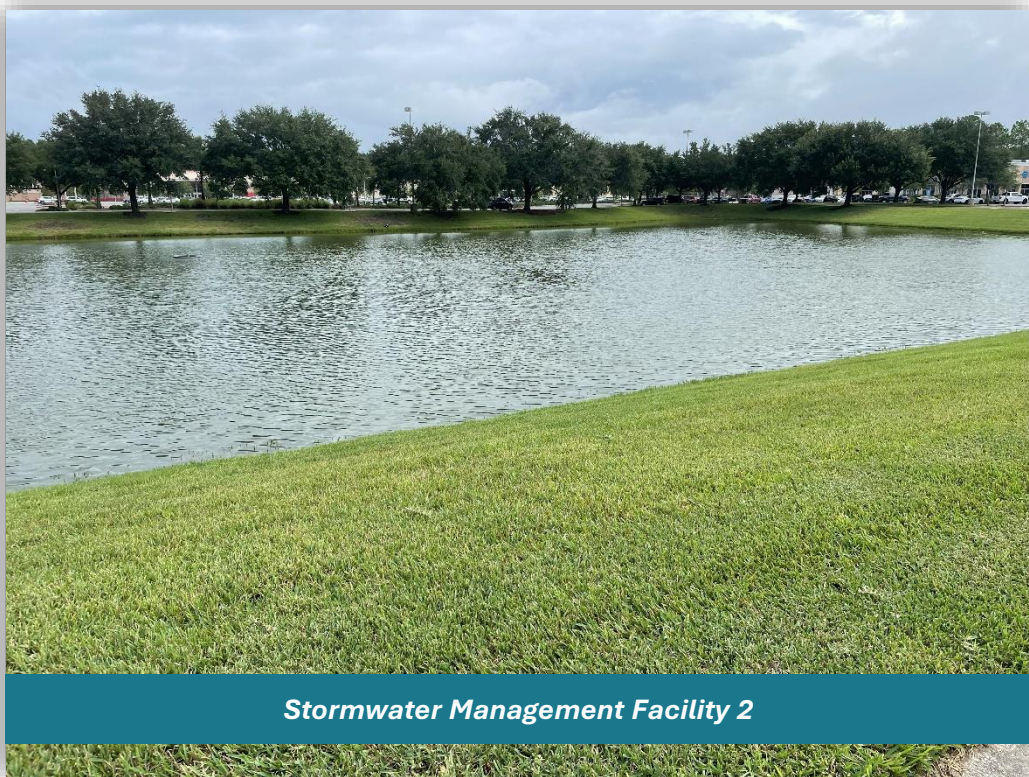
The District's stormwater management system consists of two wet detention ponds and associated control structures, mitered end sections, and pipes. During field observation, control structure at SMF-1 was observed to be functioning properly with water flowing through the orifice as intended. At SMF-2, water was observed flowing over the weir despite no recent rainfall within the previous 72-hours, suggesting the weir may be set too low or sediment and debris exist in the system downstream of the control structure.

It is recommended that the weir elevation should be analyzed and verified against the approved plans. Adjustments, repairs or downstream system cleaning should be performed to ensure compliance with the stormwater management design permitted.

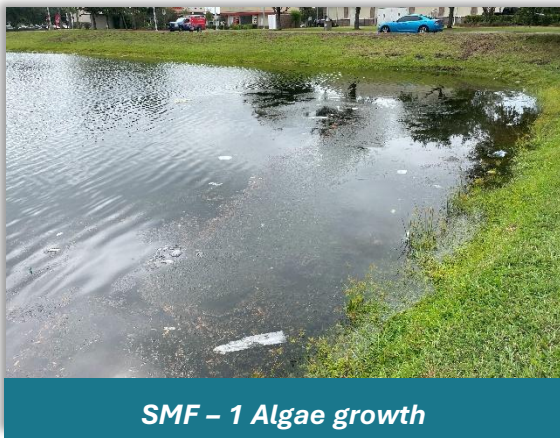
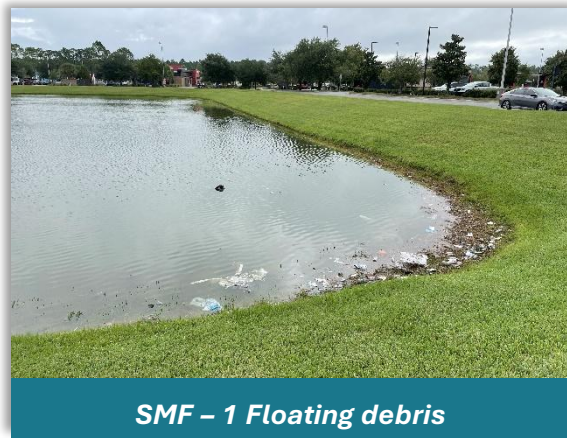
SMF-1 was observed with large quantities of algae and garbage in the water. It is recommended to implement routine pond maintenance, including algae control and debris removal. Consider aeration improvements to improve circulation or other water quality treatments.

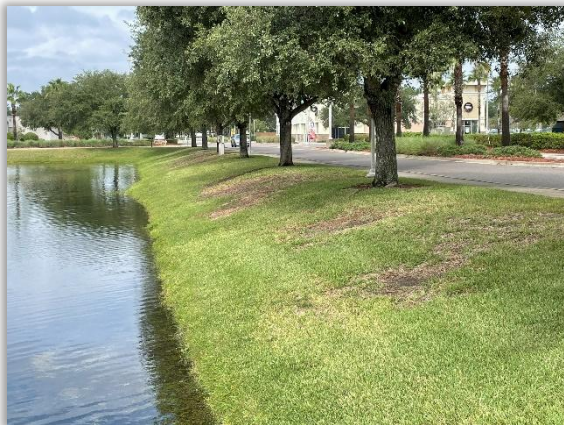
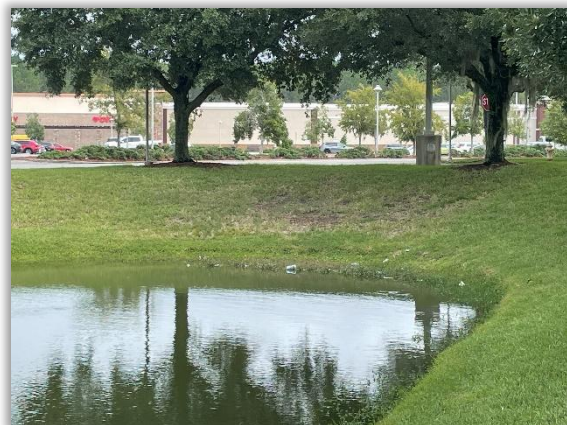
*Landscaping and Erosion Control*

Multiple areas were identified where turf grass was no longer present. In some locations, weeds had been established in place of turf, whereas in other areas, the soil remained bare and unprotected. Exposed soil presents a risk of erosion and sediment transport into the stormwater system. Restoration of turf is recommended throughout affected areas. Sod installation should be prioritized in high-risk erosion locations. Where applicable, erosion control blankets or alternative stabilization measures should be installed to ensure long-term site stability.
